CASE STUDY

Leading Customer in Steel Industry

Resolving Bearing Failures in Hot Rolling Mill Stand

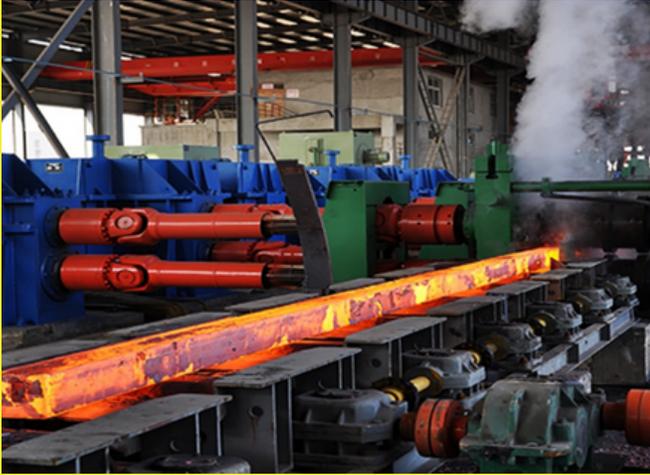
The inner ring of the four-row cylindrical roller bearing was fracturing. Bearing life was less than one year, leading to frequent maintenance and downtime.

Bearing arrangement comprised **four-row cylindrical roller bearings** along with **tapered roller thrust and ball bearings**.

- Excessively tight bearing fit caused high hoop stress, leading to inner ring fractures.
- Improper clamp fixation contributed to uneven load distribution.
- Seal orientation and bearing arrangement were not optimized for operational conditions.
