# ROLLING BEARINGS

## Bearings Failure

## 14.1 Bearing Failure

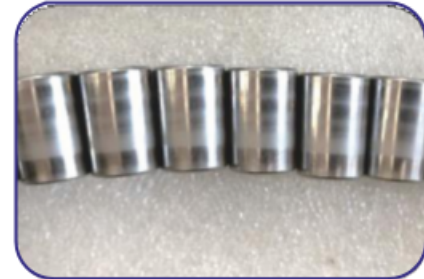
Smearing (skidding) - Occurrence of surface roughness due to inadequate lubrication between the surfaces which results in sliding/slipping of rolling elements and transfer of material between
